# Water quality technical report for surface water resources in Suriname

October - December 2023

Hydraulic Research Division

**Document:** Water quality technical report for surface water resources in Suriname – second report

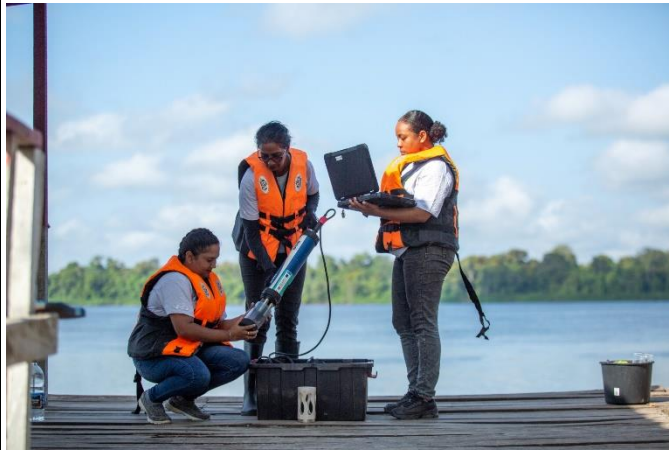
1. Water quality measurement at Apoera scaffold

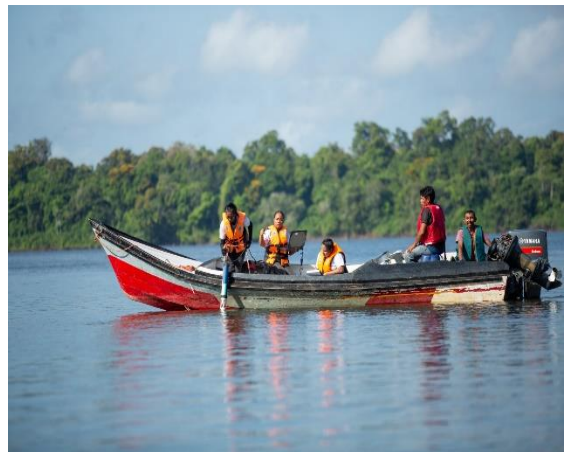
2. Water quality measurements from a boat Corantijn River

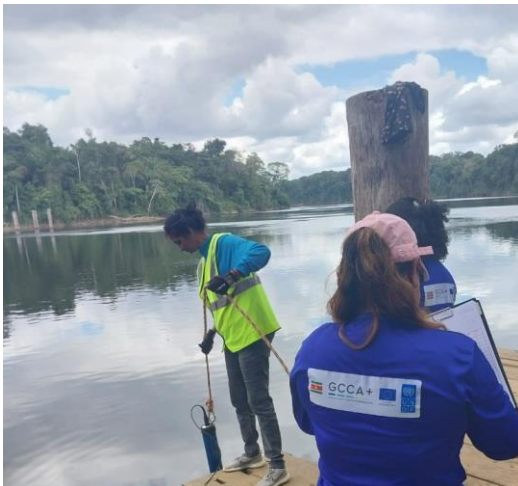
3. Water quality measurement at Witagron

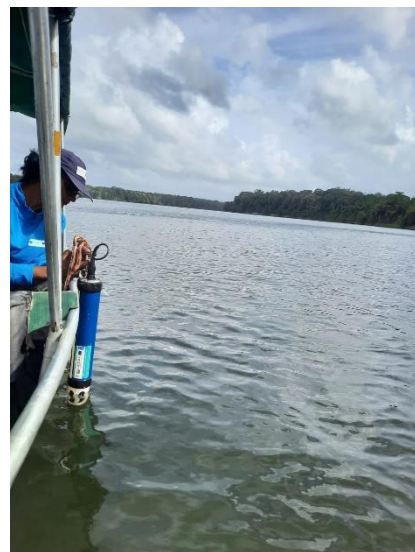
4. Water quality measurement from a boat Kabalebo creek
